Vehicle History Report

Chassis number ¹: RK5-1118450

Make: HONDA

Model: STEPWGN SPADA

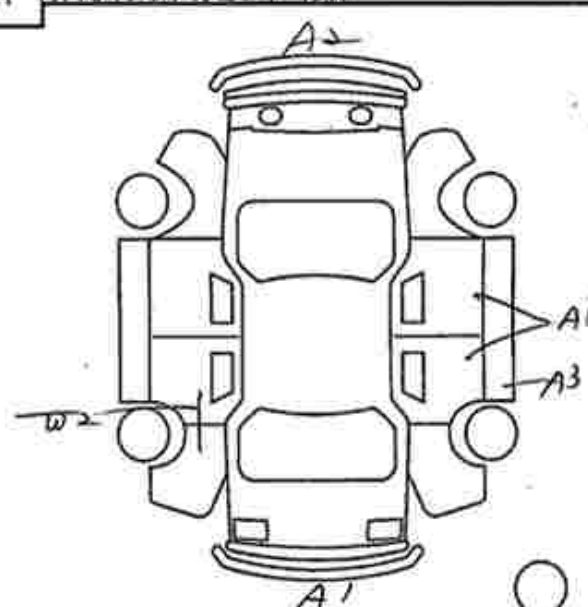
ホイール・CP
スワレノドアミラーキ
小キズ車 小し
補修
