VEHICLE DETAILS

Chassis number ¹: RK6-1202308

Make: HONDA

Model: STEPWGN SPADA

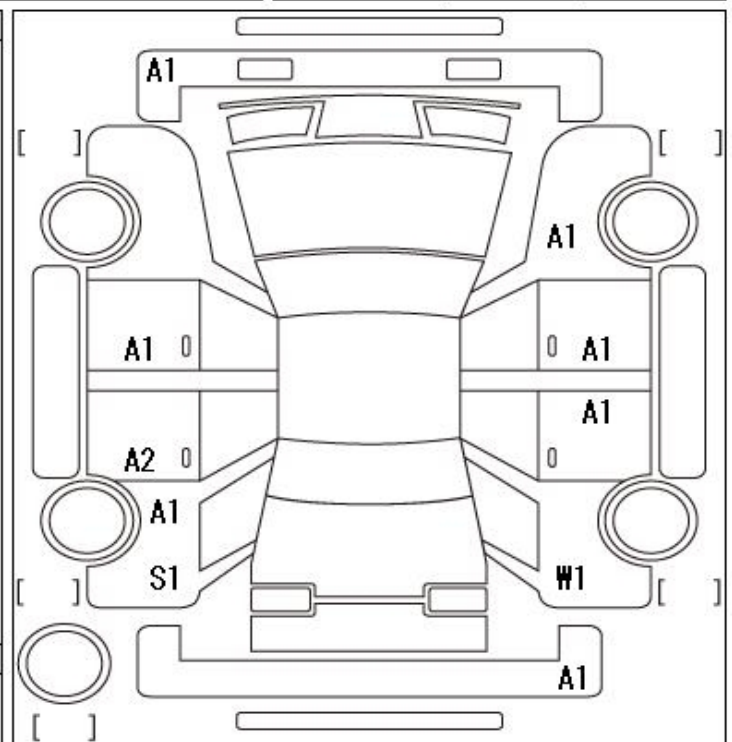
検査員記入欄
室内汚れ シートすれ小 外装うすい線傷、鉄粉付着 下廻りペイント
事務局よりご案内

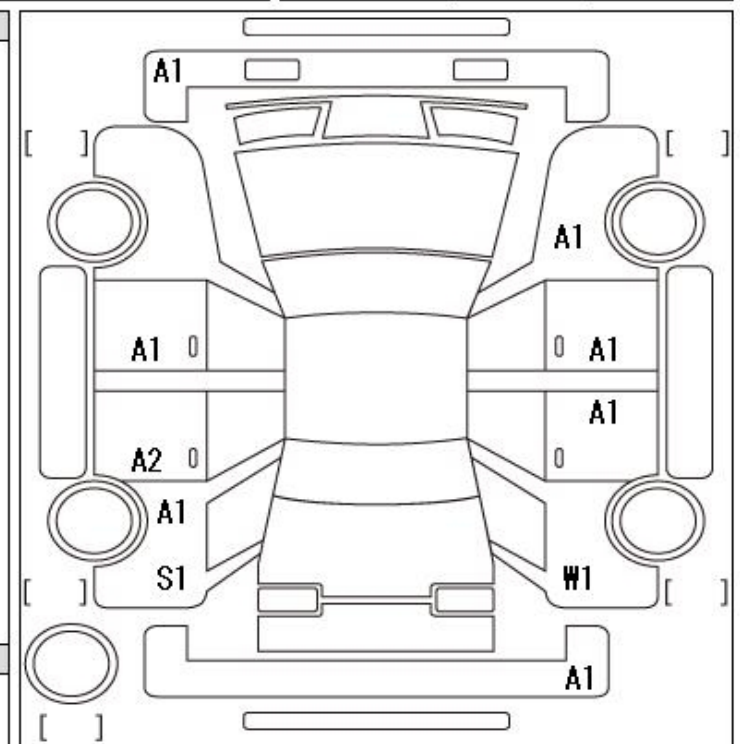
検査員記入欄
室内汚れ シートすれ小 外装うすい線傷、鉄粉付着 下廻りペイント
事務局よりご案内
