# **Vehicle History Report**

Chassis number <sup>1</sup> :	TE52-009587	Title information <sup>2</sup> :	<b>1</b>	Deregistered to Export	0
Manufacture date:	2011-01		<b>u</b> _		_
Make:	NISSAN	Accident / Repair:	<b>I</b> ⇒	No problem	
Model:	ELGRAND	Odometer rollback:		No problem	$\bigcirc$
Body:	DBA-TE52	Manufacturer	~		
Grade:	250 HIGHWAY STAR	recall:	9	No problem	~
Engine:	QR25DE	Safety grade <sup>3</sup> :	8	*****	0
Drive:	2WD	Contamination	۵.۵	No. of the second s	
Transmission:	AT	risk:	<b>Å</b>	No problem

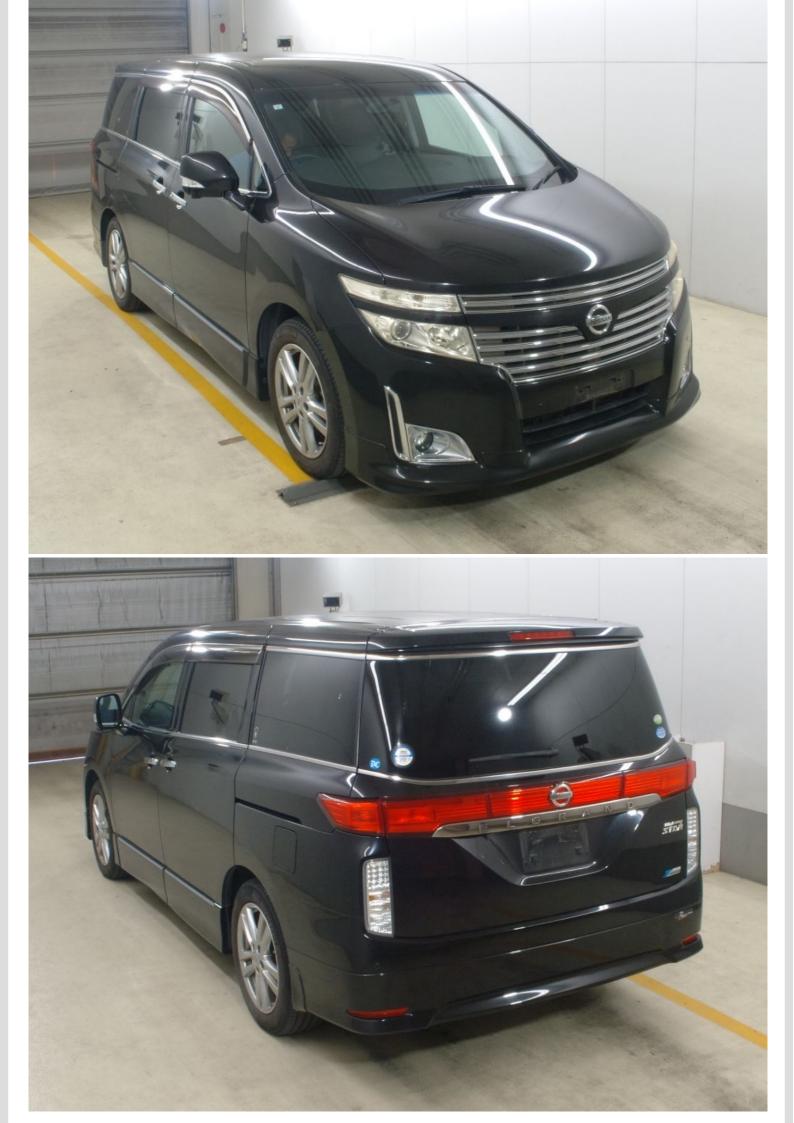
ダッシュ板ワレ シートフチシワ ホイールキズ 下層り一部サビ 外装ツヤなし 小キズ小凹うすキズ
