# Vehicle History Report

Chassis number <sup>1</sup>: GGH20-8051559

Model: VELLFIRE

Grade: 3.5Z G EDITION

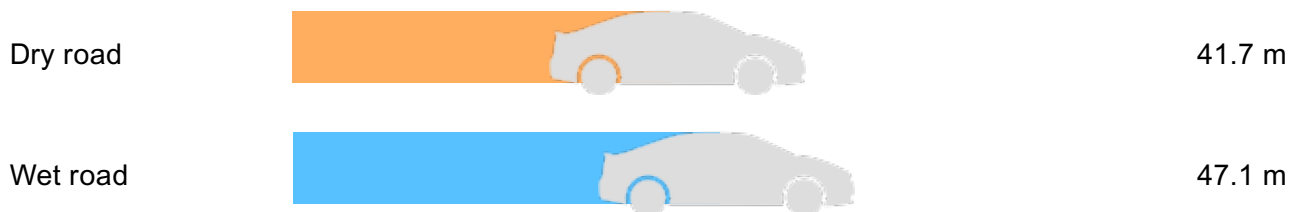
### Braking performance tests <sup>7</sup>

**<sup>7</sup> Braking Performance Tests** – Braking performance is determined by the shortness of the distance in which a vehicle can stop and the stability of the vehicle at the time of braking. This test is performed under wet and dry road conditions for a vehicle which has both a driver and a front passenger. The distance it takes for the vehicle to stop and the stability of the vehicle at the time of braking is evaluated for when the vehicle is stopped abruptly while traveling at a speed of 100km/h. The stopping distance and vehicle speed have been measured by using GPS since FY2009.

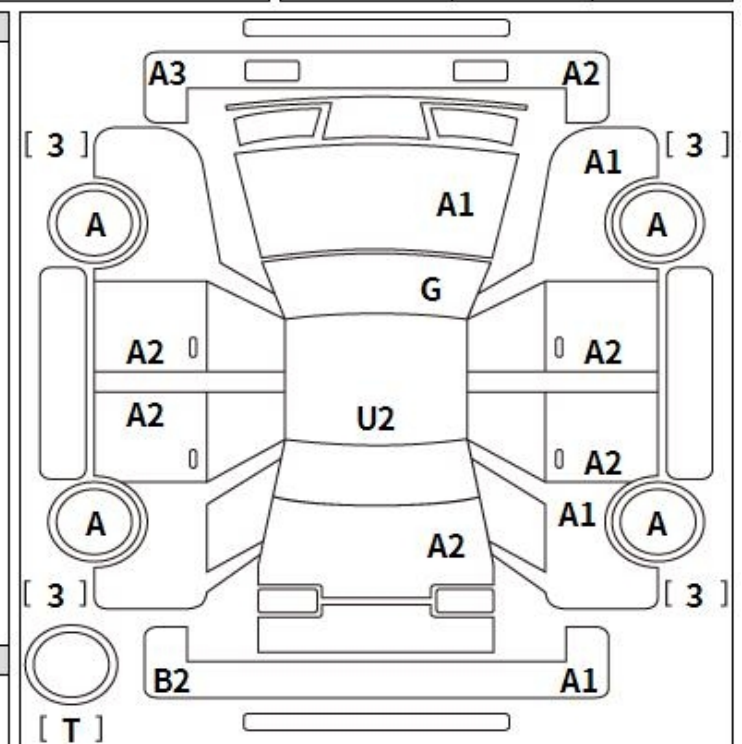
検査員記入欄
外装うすい線キズ 室内内張傷 室内薄汚れ ハンドルすれ シートすれ中 タッチP跡 バンパー下A ローダウン 社外アルミホイール
事務局よりご案内
キーケース

A: 欠 U: 欠 B: 欠を伴う欠 P: 要塗装 W: 補修跡 S: 錆 C: 腐食 G: 7D外が欠点欠 XX: 交換済み X: 要交換 内・外装評価 5段階評価(A・B・C・D・E) 1

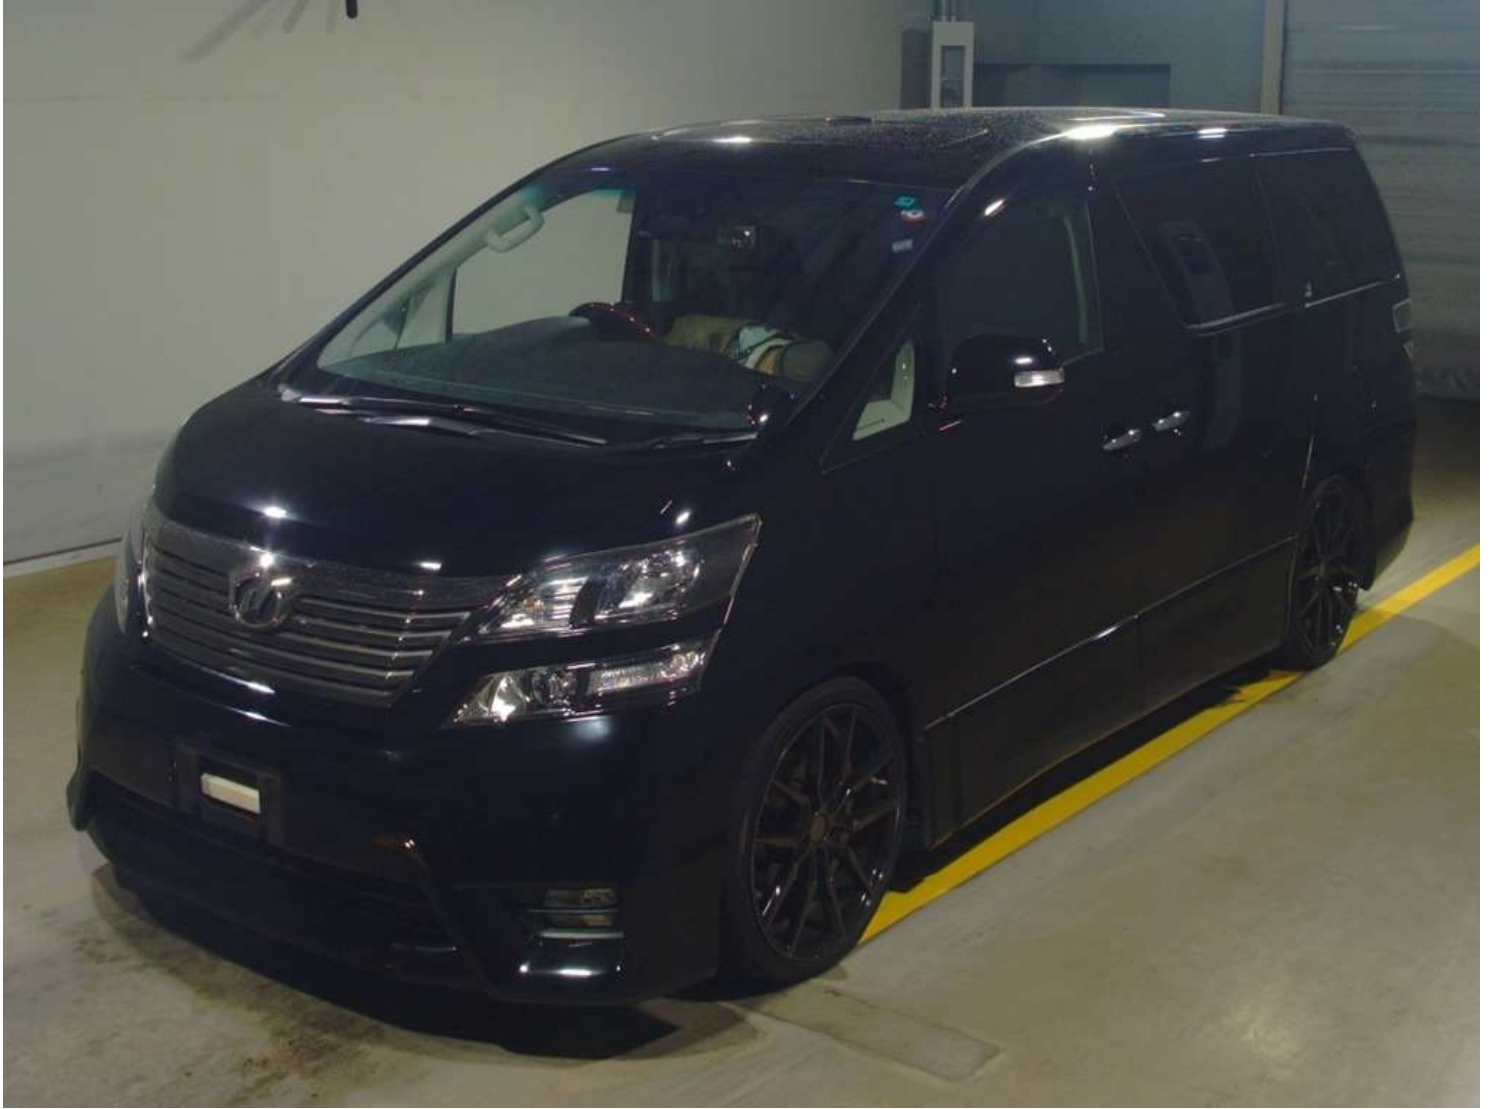
# スライドコーナー

35023	車種 (自家用以外は記入)	排気量	型式	評価点
	初年度年月	車名	グレード	4
23/9月	サエル717	3.500cc	EDBA-GGHZ1W	内装 B
		4WD	2WD

車検	年	月	ソフト	AT	タイヤ	PS	PS	PS	PS
走行	85,177	Km	冷房	AAC	セルポイント	カワ	TV	PB	ITB
外色	70	色	カラー	202	★ツインサエル7!!				
内装	サドル	色	内装		★メ-カーツイン+ゼ+TV!!				
車検	輸入区分	ハンドル	名義変更	月	★後席フロントダウン!!				
ディーラー	並行	左・右		日	★107-バックドア!!

リサイクル	預託金	16,360	円	乗車定員	7人	車台	GGH20-805/559
○注意事項 (車検・不具合箇所および状態等)						シリアル	
★お値107-バック!! ★BE=7-!!							
★ETC!! ★希外202+AW!!

○検査員報告 (USS使用済)

シート 5L 外足(20)?

トール 4L 5L

ホイール 4L

各 4L 5L

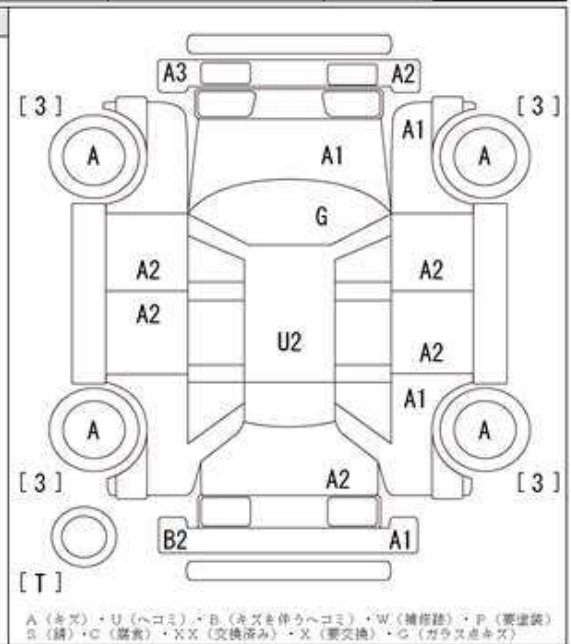
セールスポイント	特記事項・不具合箇所
プッシュスタート 両側パワースライド 注意事項	外装うすい線キズ 室内内張傷 室内薄汚れ ハンドルすれ シートすれ中 タッチP跡 パンパー下A ローダウン 社外アルミホイール
