# **Vehicle History Report**

Chassis number <sup>1</sup> :	TE52-009587	Title information <sup>2</sup> :	<b>1</b>	Deregistered to Export	0
Manufacture date:	2011-01		<b>u</b> _		_
Make:	NISSAN	Accident / Repair:	<b>I</b> ⇒	No problem	
Model:	ELGRAND	Odometer rollback:		No problem	$\bigcirc$
Body:	DBA-TE52	Manufacturer	~		
Grade:	250 HIGHWAY STAR	recall:	9	No problem	~
Engine:	QR25DE	Safety grade <sup>3</sup> :	8	*****	0
Drive:	2WD	Contamination	۵.۵	No. of the second s	
Transmission:	AT	risk:	<b>Å</b>	No problem

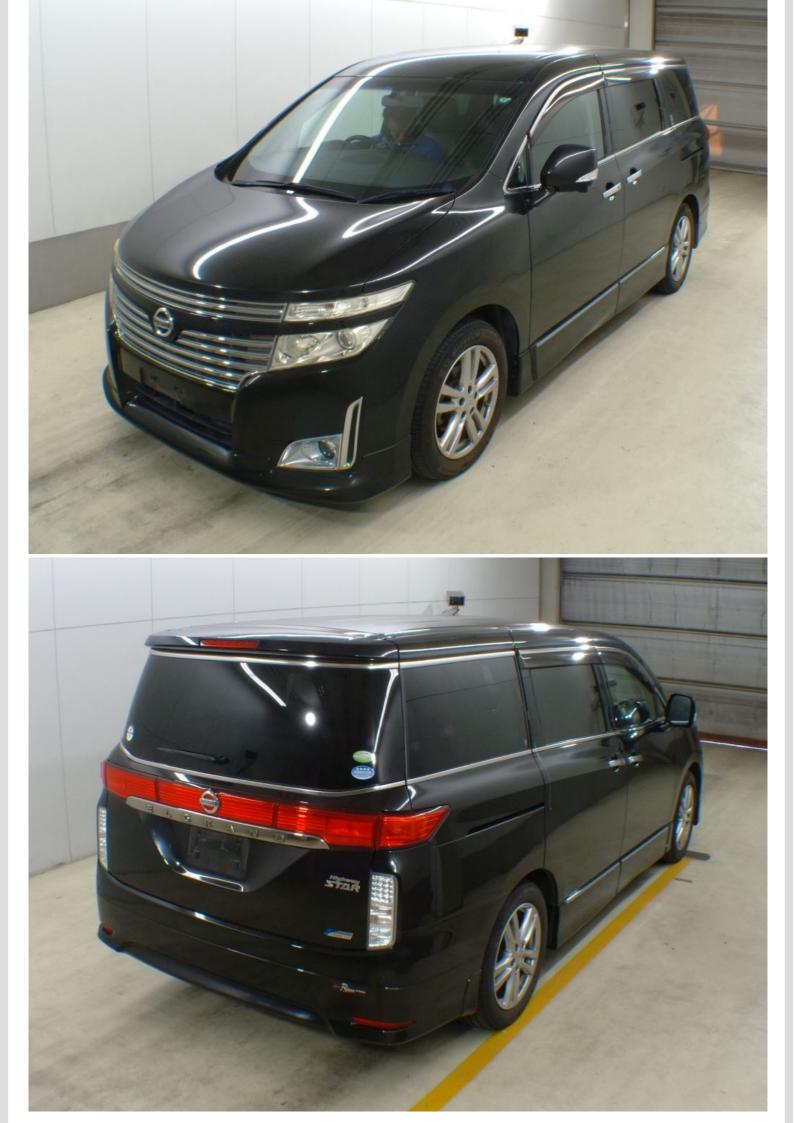
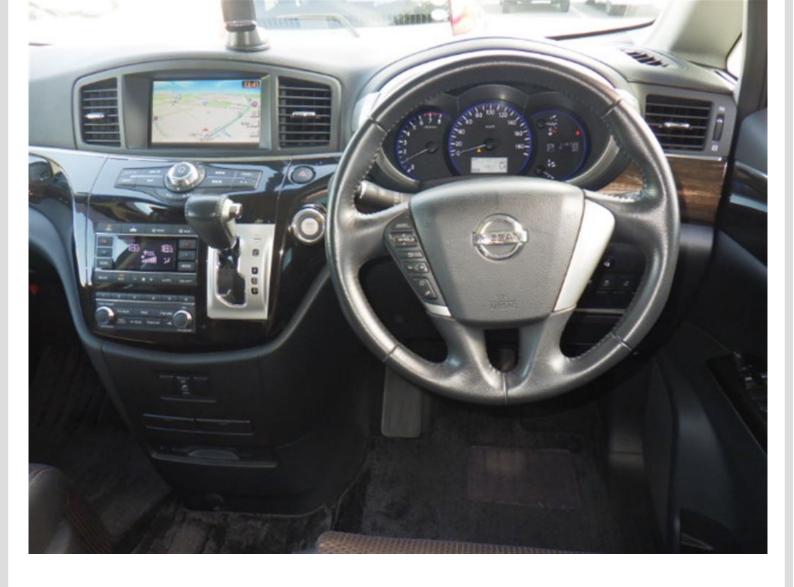
早些(自家用い	明白記入	2500		C DBA-TE52		Mila
53425	H23/2 18	<sup>車 名</sup> 目記 エルグラ		50 25	-ド 0ハイウェイス ター	<b>11111</b> 21110	4 /***
1.検	#	月 E	シフト	IAT			
目行	114, 739	kn	* 5	AAC	セールスポイント		
1元8 1 2 1 2 1	ėN	カラーね GAE	-		純正メーカー   アラウンドビ		
ガソリ	2			E TEN	後席フリッフ		
**  -	输入医分	ハンドル			ハーフレザー 両側オートス		F7
19121 1	6, 190 P	7 .	÷,	1 # Wa			
				草台胞	009587		
キセノンヘッドライト、インテリキー シリア
