VEHICLE DETAILS

Chassis number ¹: RK5-1210230

Make: HONDA

Model: STEPWGN SPADA

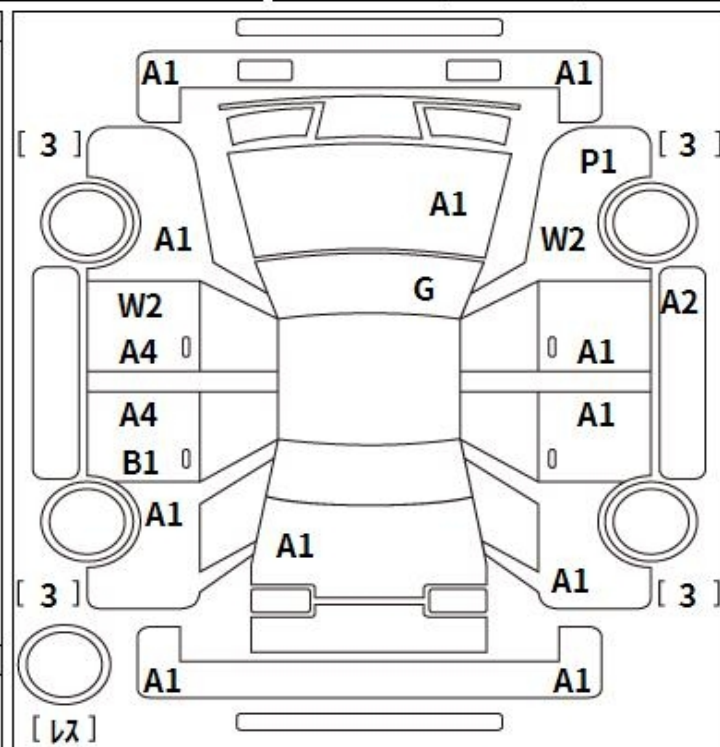
検査員記入欄
外装しみ ミラー電格不良 外装うすい線キズ 室内汚れ コンソール傷小 ハンドルすれ シフトノブすれ ダッシュ板のり付 天張汚れ シートしみ小 シートへたり 社外ステレオ リヤスポイラーP剥がれ
事務局よりご案内

A: 外装 U: 内装 B: 外装を伴う内装 P: 要塗装 W: 補修跡 S: 錆 C: 腐食 G: 70%以上が剥がれ XX: 交換済み X: 要交換 内・外装評価 5段階評価(A・B・C・D・E) 1

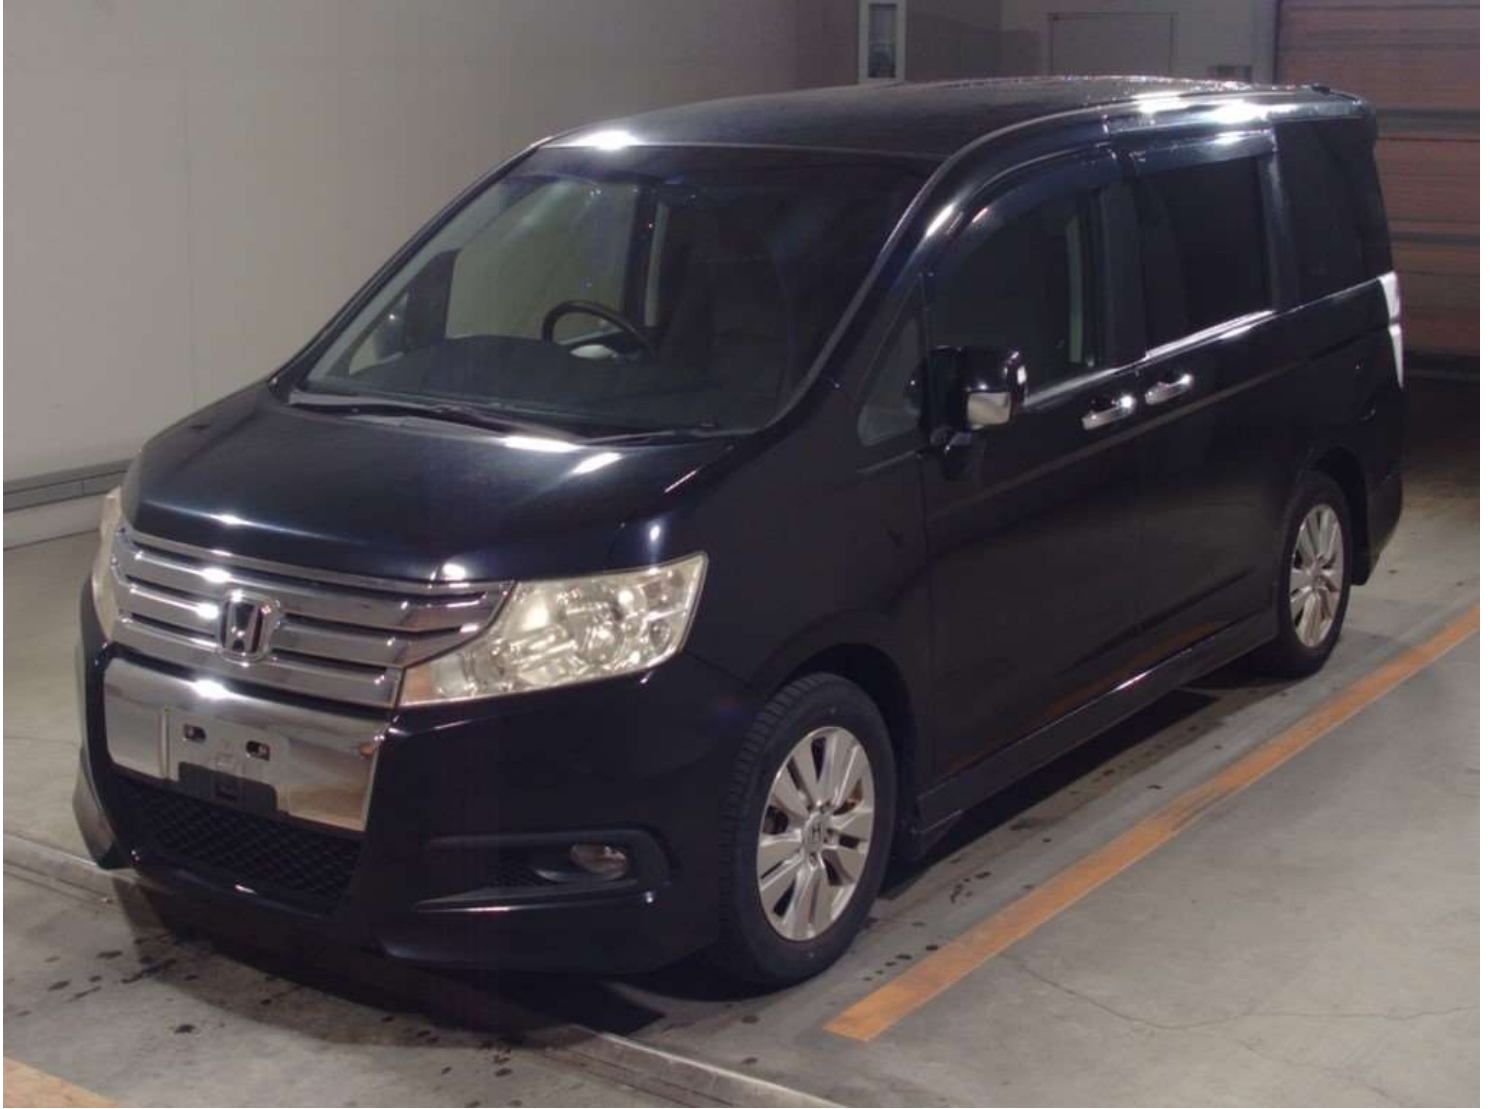
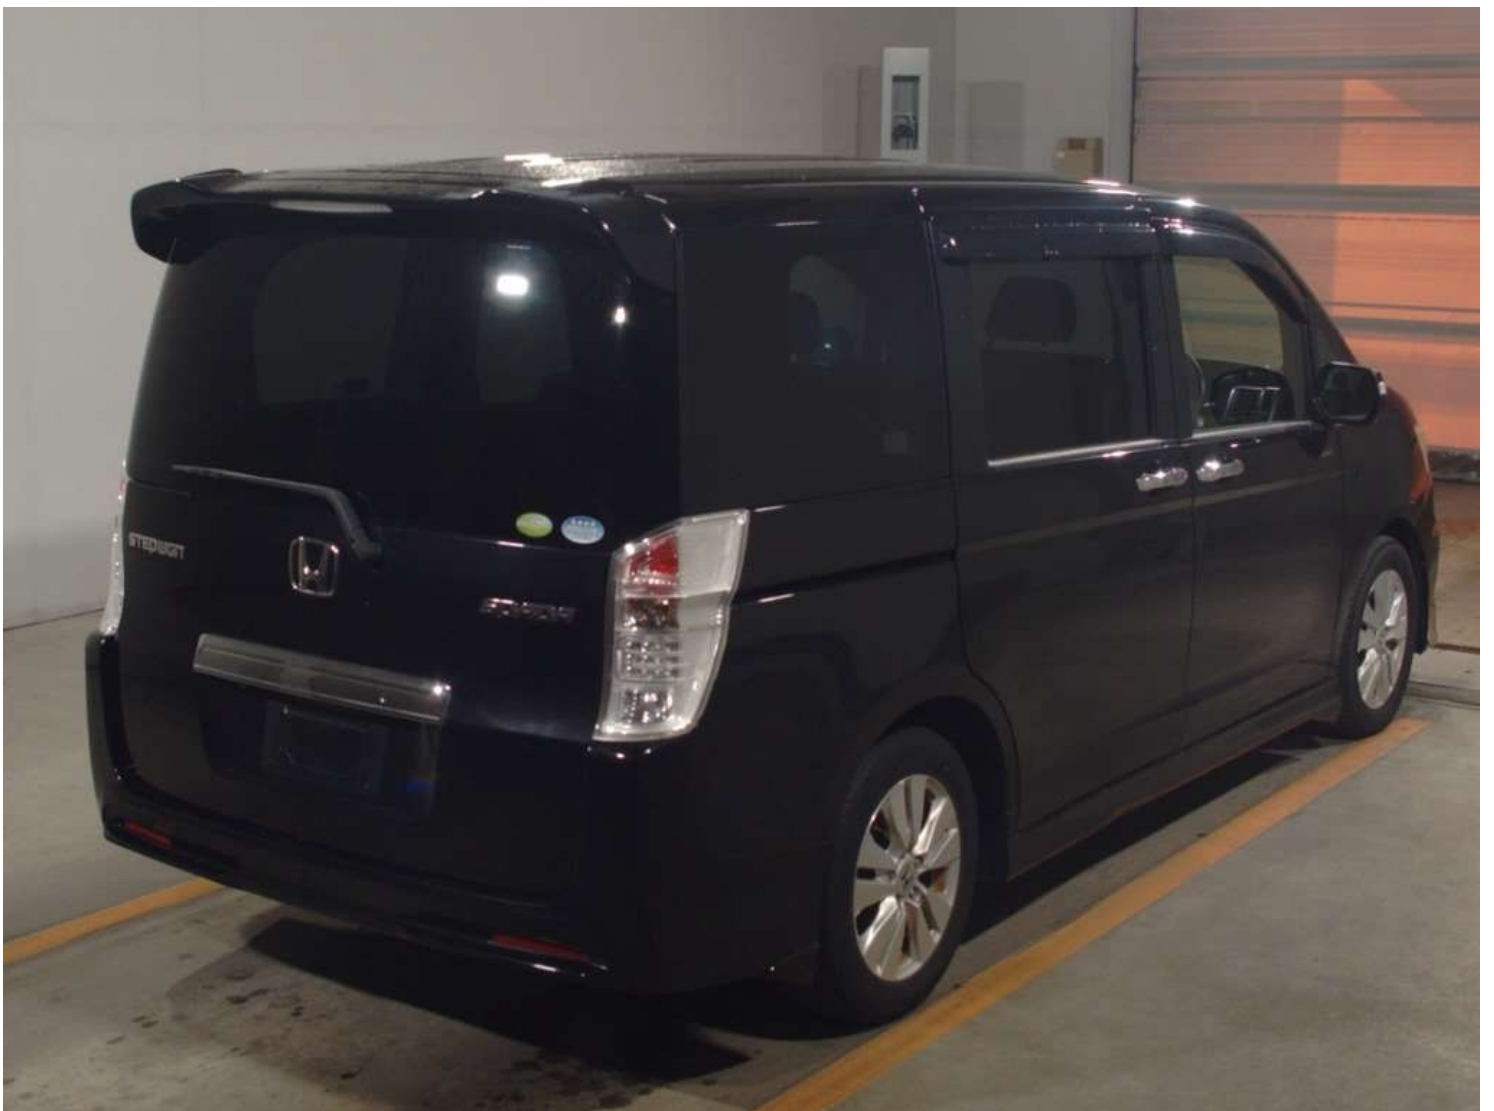
出品番号
3435

現メーター指示					km
[査定員記入]					
Fガラス	ト石	ヒビワレ			
ドアミラー	キX・ワレ	ホイール(CP)	キX・ワレ		
車内シヤ. 25"					
ナビロム, 20.4L, 電格ジヤ					
シート

評価点	
3.5	
内装	外装
B	B
